# NAVAL POSTGRADUATE SCHOOL

## THESIS

CHARACTERIZATIONS OF PREHEATED AND  
NON-PREHEATED HY-80 STEEL WELDMENTS  
BY TRANSMISSION ELECTRON MICROSCOPY

September 1983

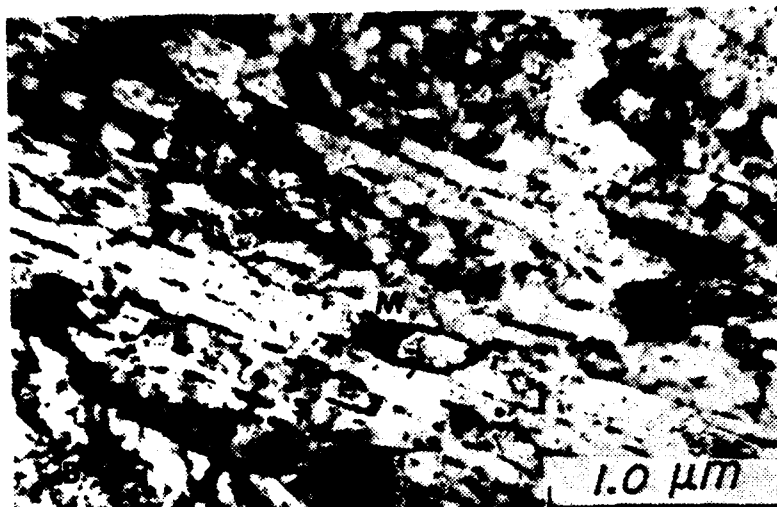
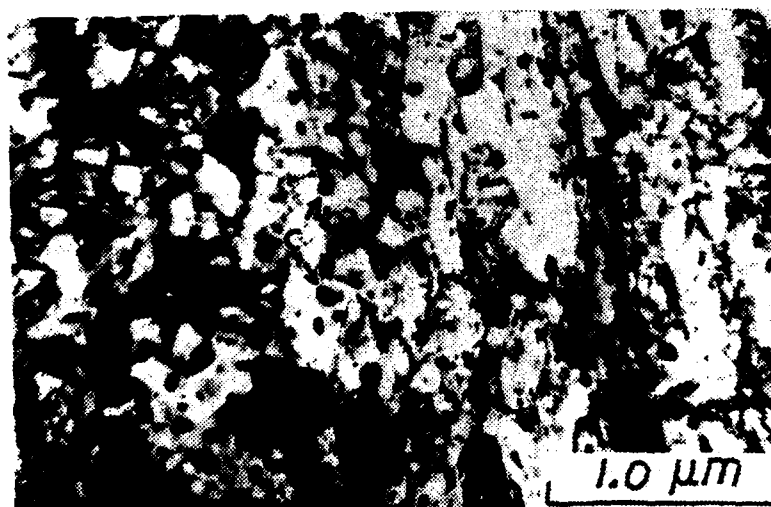
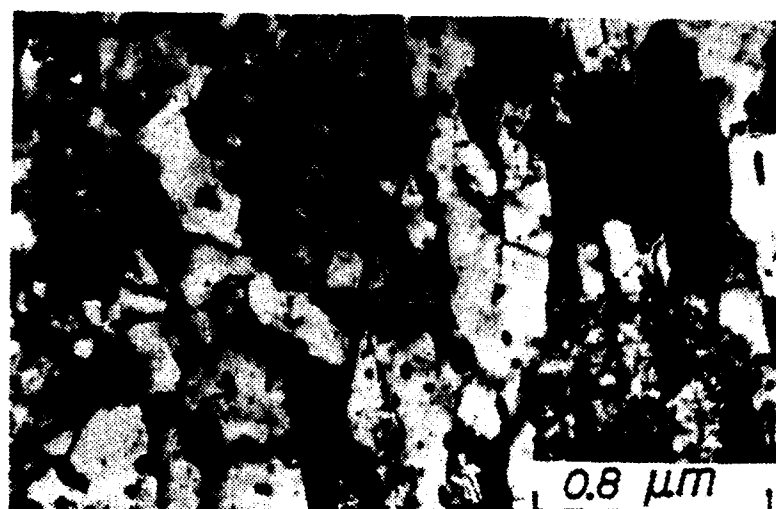
Figure 12. TEM Micrographs of Location A

Tempered Martensite = (M)  
 Tempered Bainite = (B)  
 Temper Carbides = (C)  
 Prior Austenite  
 Grain Boundary = (gb)

Location A' is in the area of the non-preheated base metal. The microstructures observed were the same as found in A, Figures 10, 11 and 12(a-f).

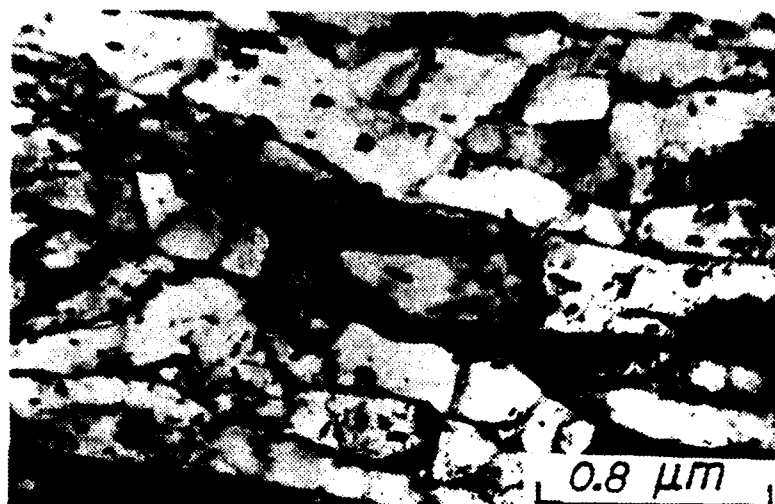
Figure 15. TEM Micrographs of Location B

Location B is in the region of slightly depressed hardness near the visible heat affected zone approximately 3.2 millimeters from the fusion line. The microstructure as seen with optical and scanning electron microscopy in "B" appears to be very similar to that within "A", Figures 13 and 14. Examination of the specimen in Location B by transmission electron microscopy reveals a microstructure consisting of tempered bainite and tempered martensite with uniform distribution of cementite. These spherical cementite particles are approximately the same size as those observed in A. The cementite in A are still present in B. The martensite and bainite average lath sizes are about 0.3 and 0.5 microns respectively. Figure 15(a-f) illustrates the typical microstructures found in Location B.

Tempered Martensite	=	(M)
Tempered Bainite	=	(B)
Temper Carbides	=	(C)
Prior Austenite		
Grain Boundary	=	(gb)

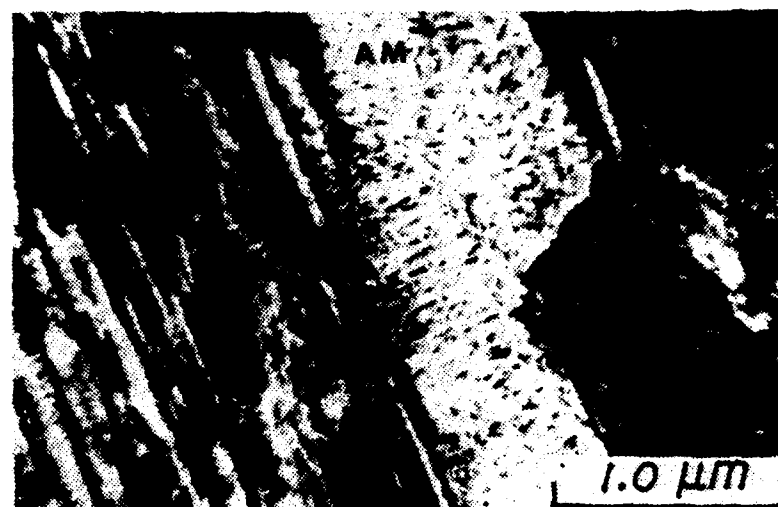
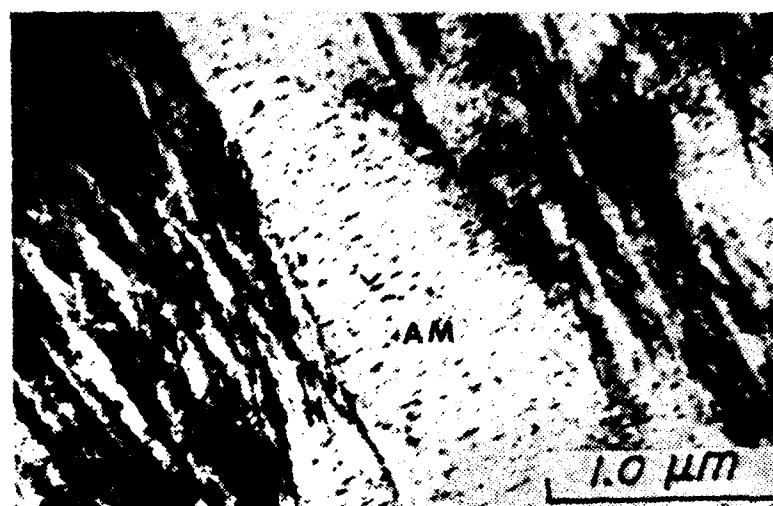
Figure 21. TEM Micrographs of Location D

Location D is the grain coarsened heat affected zone near the visible fusion line. Optical investigation clearly reveals the significant increase in grain size, Figure 19. The microstructure appears to be martensite, which is more easily recognized in Figure 20, a scanning electron micrograph at 2000X. The TEM specimens exhibit a heavily dislocated fine lath martensite (0.2 microns average) mixed with a coarser autotempered martensite (0.8 microns average). The spherodized carbides present in "A", "B" and "C" are no longer visible within the microstructure of D indicating complete austenization and dissolution of the temper carbides. The presence of a transformation twinned martensite within the coarse ferrite laths was observed but very infrequently, Figures 21(a-f).

Autotempered Martensite (AM)

Transformation Twinned Martensite (TT)
